Griffith Hospital

Environmental Monitoring

June 2024 – November 2024, Summary Report

ADCO Constructions

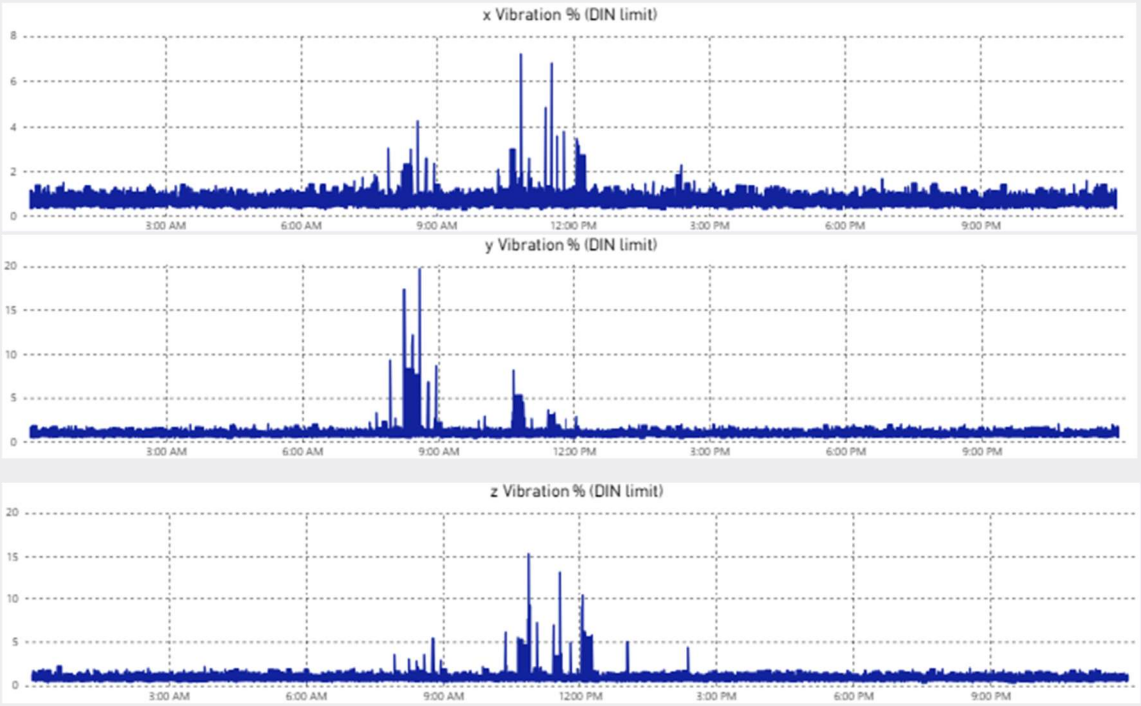
JUNE 2024

The monthly output graphs for each plane are shown here. The maximum deflection recorded in each axis were:

X = 7.20% (0.360mm/s)

Y = 19.68% (0.984mm/s)

Z = 15.28% (0.764mm/s)

Note: Data Transmission ceased 18th June. ADCO are making efforts to find cause and resolve issue on site.

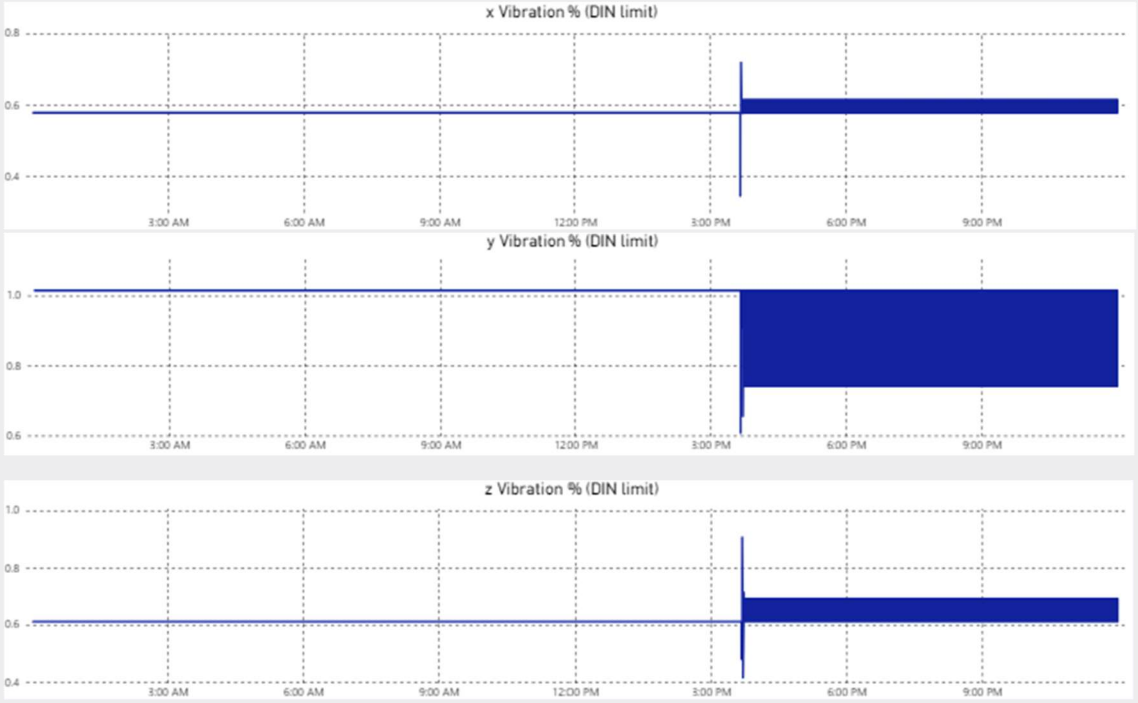
JULY 2024

The monthly output graphs for each plane are shown here. The maximum deflection recorded in each axis were:

X = 0.72% (0.03mm/s)

Y = 1.01% (0.05mm/s)

Z = 0.91% (0.04mm/s)

Note: Data Transmission ceased 30th June and recommenced 31st July. This was due to relocation of sensor

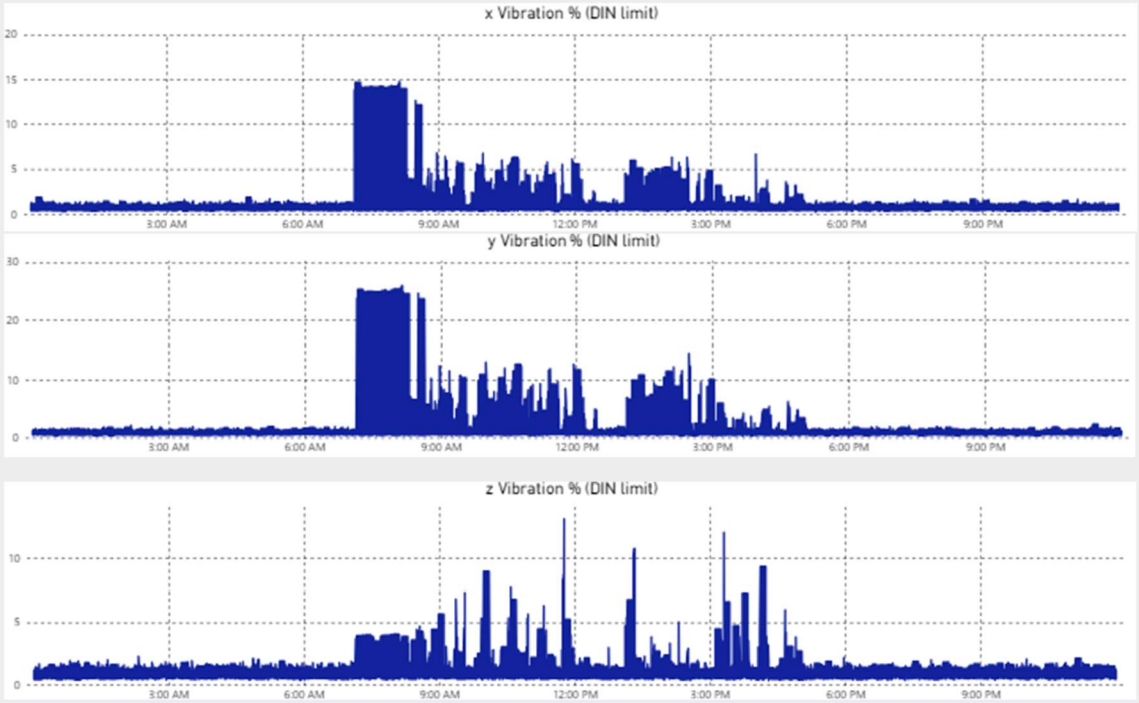
AUGUST 2024

The monthly output graphs for each plane are shown here. The maximum deflection recorded in each axis were:

X = 14.72% (0.73mm/s)

Y = 25.95% (1.29mm/s)

Z = 13.11% (0.65mm/s)

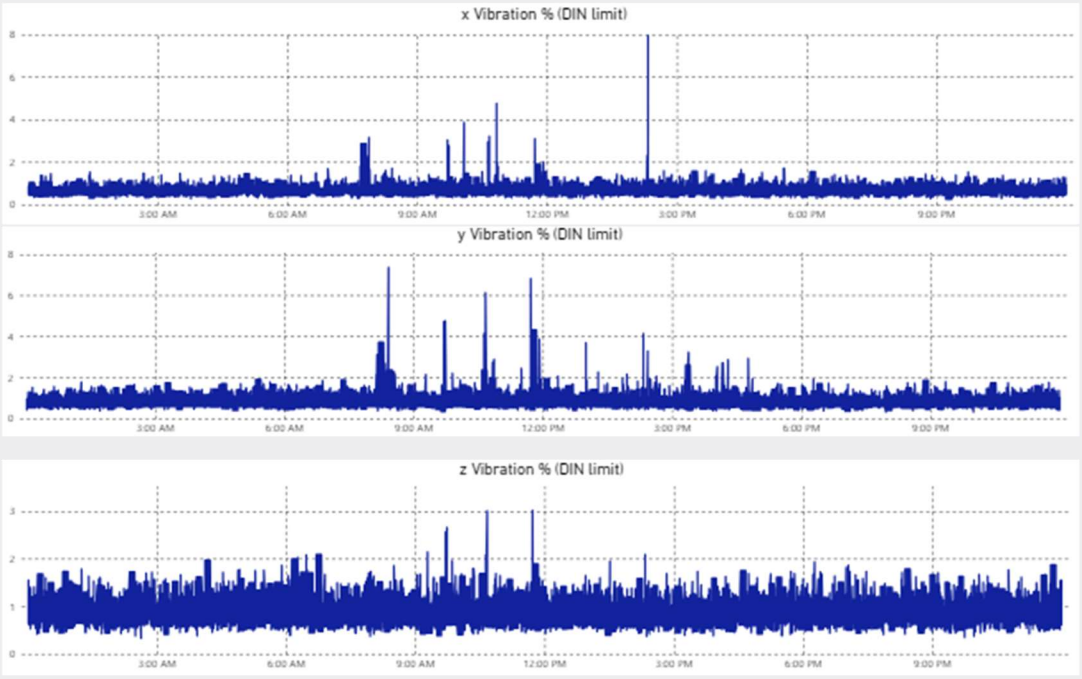
SEPTEMBER 2024

The monthly output graphs for each plane are shown here. The maximum deflection recorded in each axis were:

X = 7.94% (0.397mm/s)

Y = 7.37% (0.368mm/s)

Z = 3.02% (0.151mm/s)

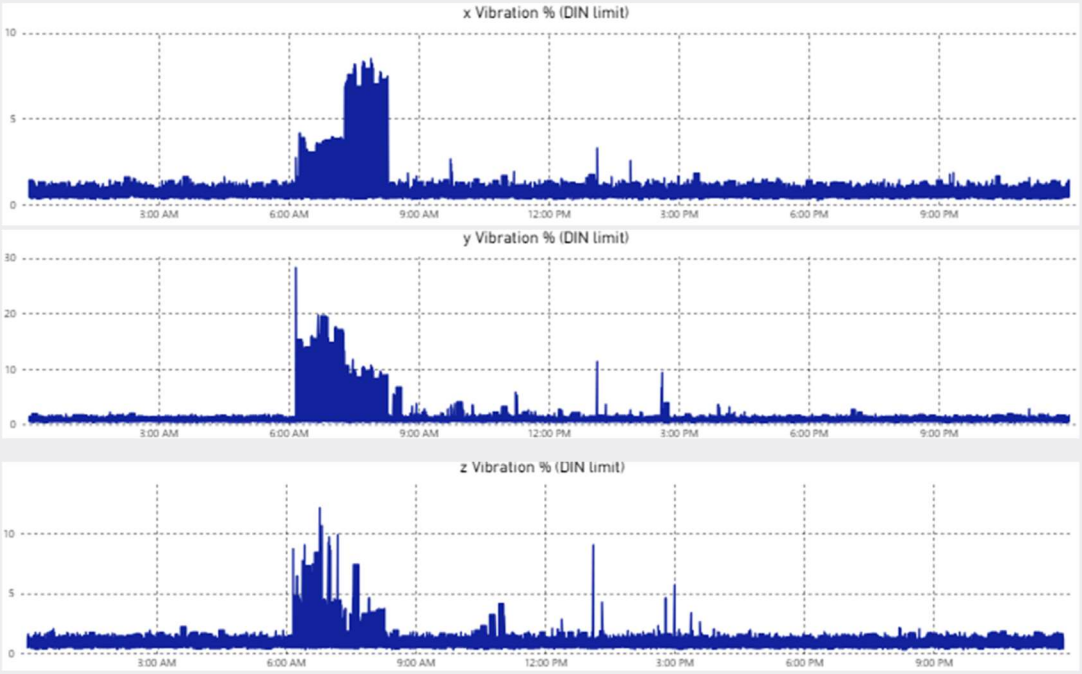
OCTOBER 2024

The monthly output graphs for each plane are shown here. The maximum deflection recorded in each axis were:

X = 8.51% (0.425mm/s)

Y = 28.28% (1.414mm/s)

Z = 12.21% (0.610mm/s)

Note: The Y axis maximum deflection was recorded at 6:09am 24th October.

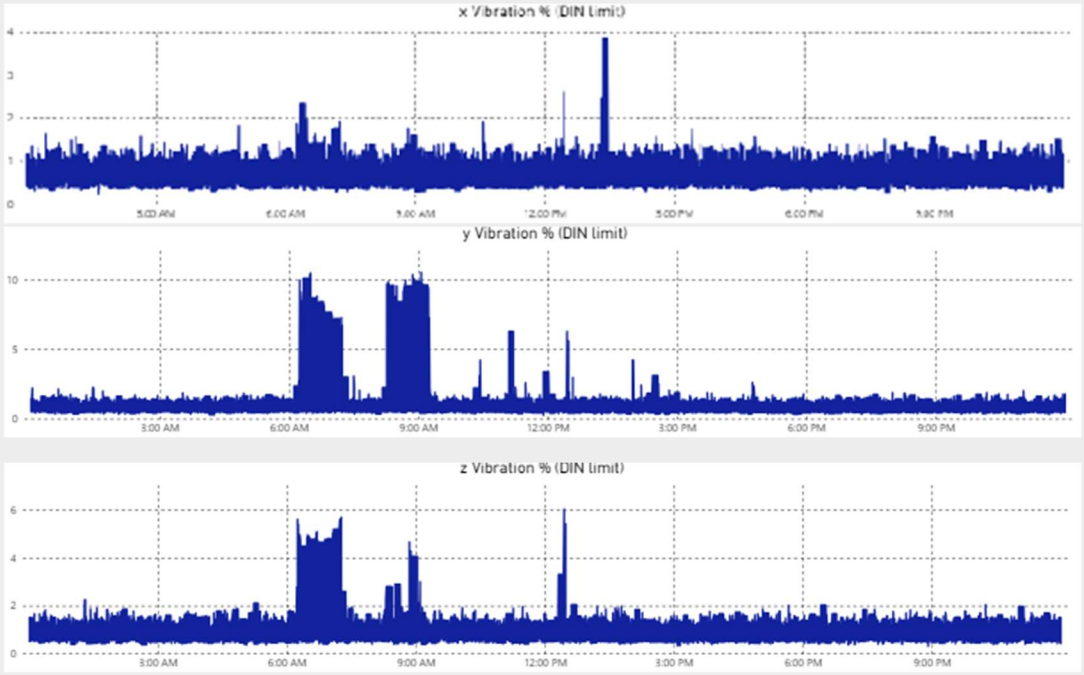
NOVEMBER 2024

The monthly output graphs for each plane are shown here. The maximum deflection recorded in each axis were:

X = 3.87% (0.193mm/s)

Y = 10.53% (0.526mm/s)

Z = 6.03% (0.301mm/s)

Note: Max deflection on Y axis was recorded at 6:28am on Thursday 7th November.

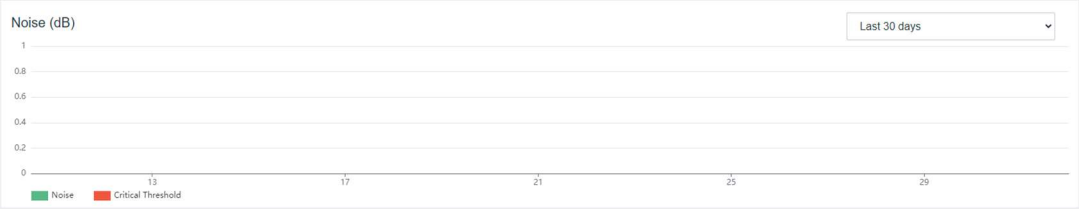
NOISE READINGS FROM NOISAU-005 – MEDICAL IMAGING JUNE

Noise recordings ceased on 3rd November due to unforeseen power loss, ADCO have identified the cause and have actions in place to have back online. Further technical difficulties have been identified and a new device is required.

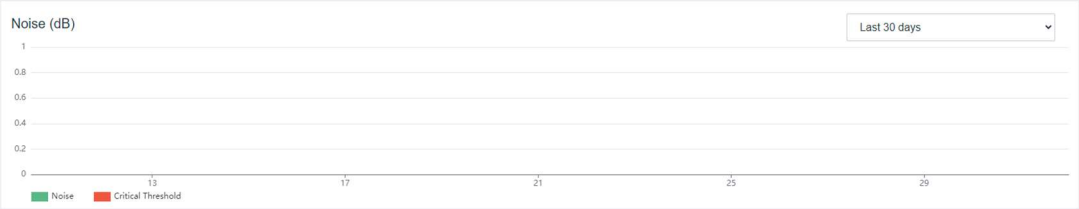
NOISE READINGS FROM NOISAU-008 – STAFF ACCOMMODATION JUNE

The noise readings from sensor NOISAU-008N, ceased due to Technical Difficulties ADCO is working to identify cause and rectify.

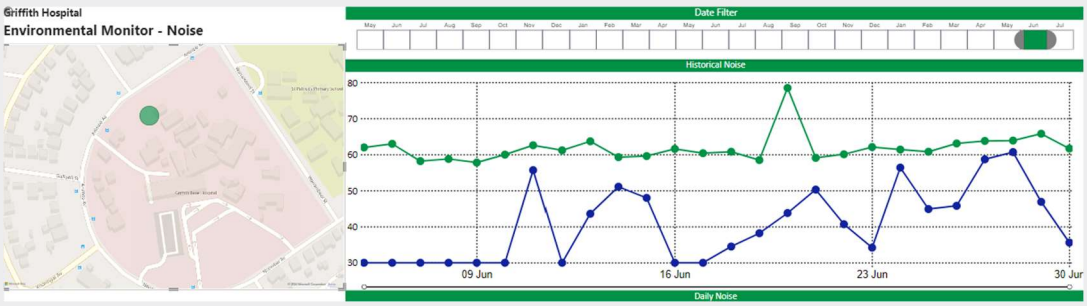
NOISE READINGS FROM NOISAU-009 – SITE SHEDS JUNE

The noise readings from sensor NOISAU-009, located near the ADCO Site Sheds showed a peak noise value of 78.5dB on 20th June 2024.

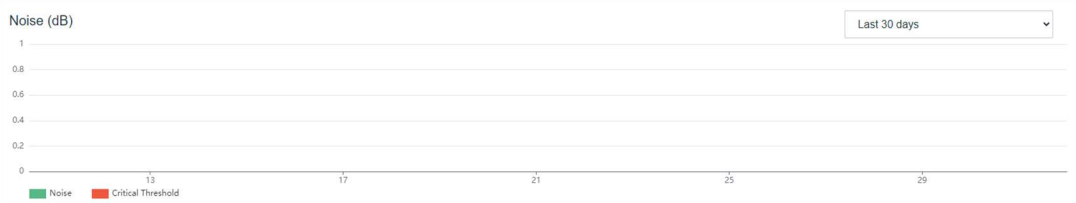
NOISE READINGS FROM NOISAU-005 – MEDICAL IMAGING JULY

Noise recordings ceased on 3rd November due to unforeseen power loss, ADCO have identified the cause and have actions in place to have back online. Further technical difficulties have been identified and a new device is required.

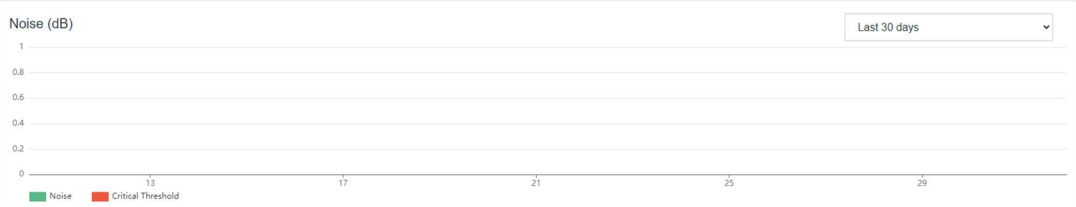
NOISE READINGS FROM NOISAU-008 – STAFF ACCOMMODATION JULY

The noise readings from sensor NOISAU-008N, ceased due to Technical Difficulties ADCO is working to identify cause and rectify.

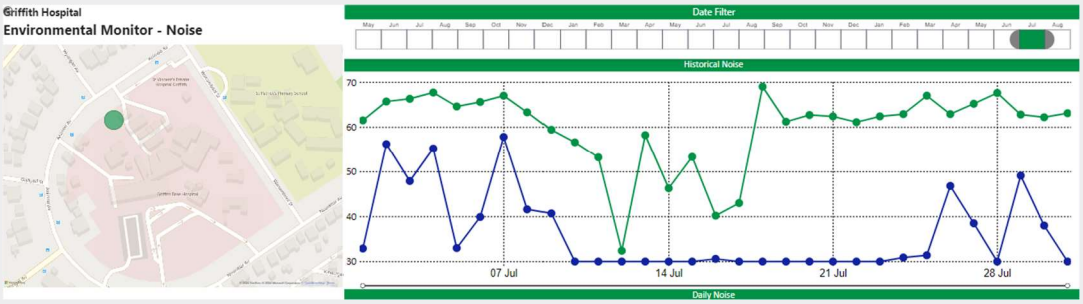
NOISE READINGS FROM NOISAU-009 – SITE SHEDS JULY

The noise readings from sensor NOISAU-009, located near the ADCO Site Sheds showed a peak noise value of 69.0dB on 18th July 2024.

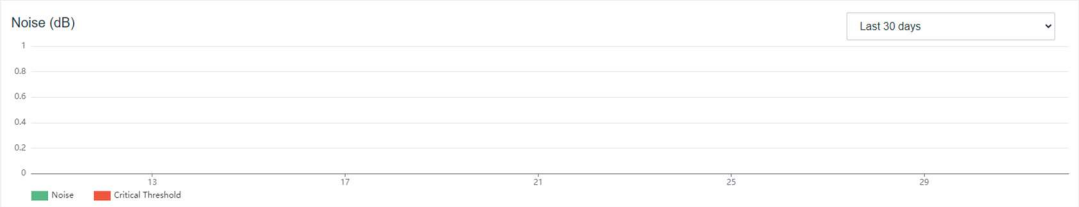
NOISE READINGS FROM NOISAU-005 – MEDICAL IMAGING AUGUST

Noise recordings ceased on 3rd November due to unforeseen power loss, ADCO have identified the cause and have actions in place to have back online. Further technical difficulties have been identified and a new device is required.

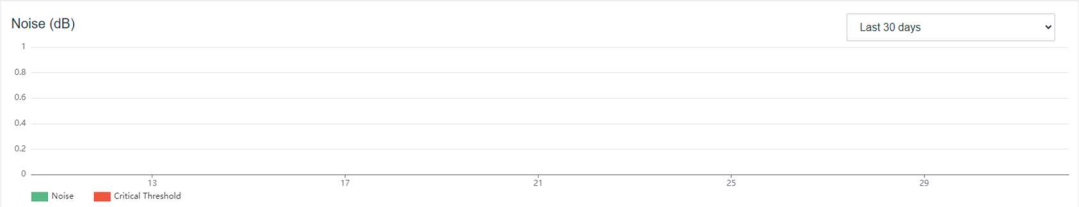
NOISE READINGS FROM NOISAU-008 – STAFF ACCOMMODATION AUGUST

The noise readings from sensor NOISAU-008N, ceased due to Technical Difficulties ADCO is working to identify cause and rectify.

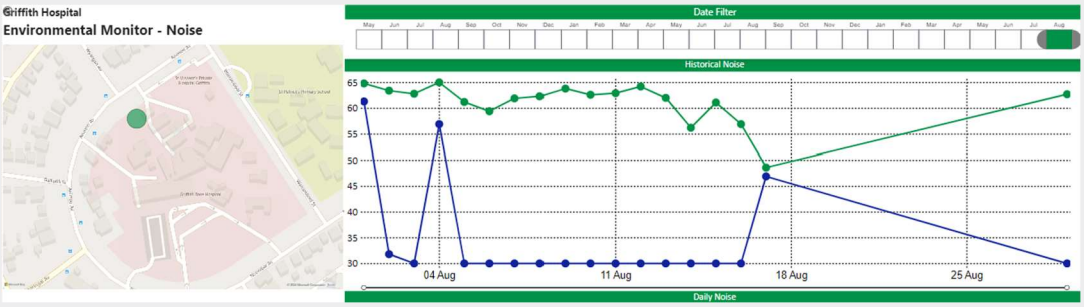
NOISE READINGS FROM NOISAU-009 – SITE SHEDS AUGUST

The noise readings from sensor NOISAU-009, located near the ADCO Site Sheds showed a peak noise value of 65.0dB on 4th August 2024.

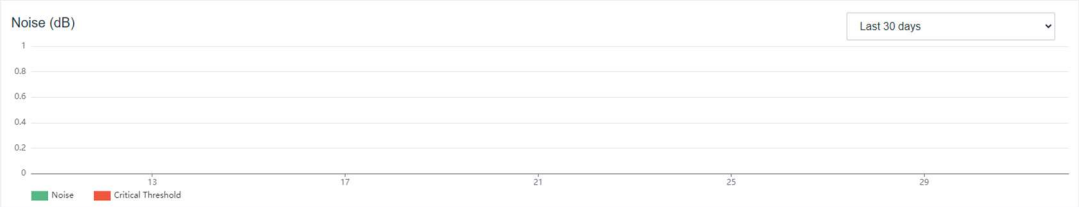
NOISE READINGS FROM NOISAU-005 – MEDICAL IMAGING SEPTEMBER

Noise recordings ceased on 3rd November due to unforeseen power loss, ADCO have identified the cause and have actions in place to have back online. Further technical difficulties have been identified and a new device is required.

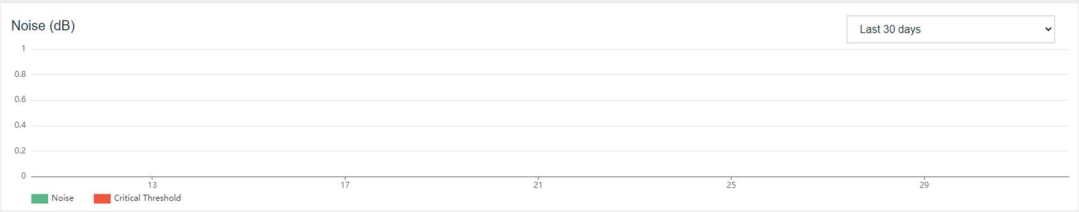
NOISE READINGS FROM NOISAU-008 – STAFF ACCOMMODATION SEPTEMBER

The noise readings from sensor NOISAU-008N, ceased due to Technical Difficulties ADCO is working to identify cause and rectify.

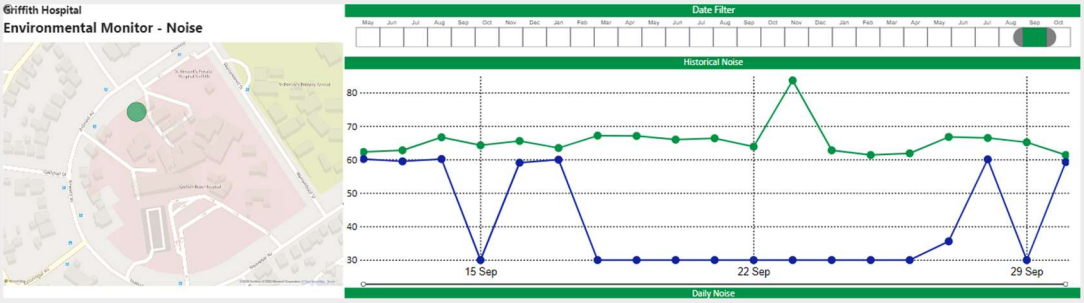
NOISE READINGS FROM NOISAU-009 – SITE SHEDS SEPTEMBER

The noise readings from sensor NOISAU-009, located near the ADCO Site Sheds showed a peak noise value of 83.7dB on 23rd September 2024.

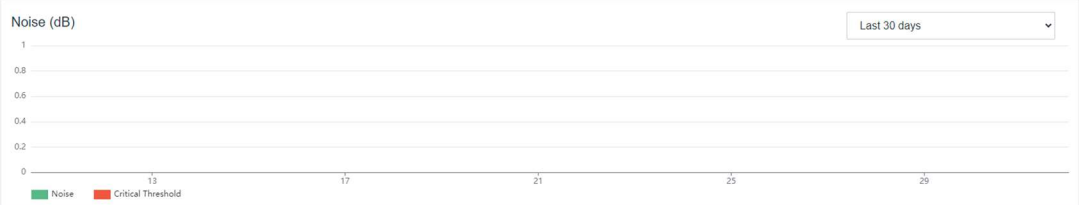
NOISE READINGS FROM NOISAU-005 – MEDICAL IMAGING OCTOBER

Noise recordings ceased on 3rd November due to unforeseen power loss, ADCO have identified the cause and have actions in place to have back online. Further technical difficulties have been identified and a new device is required.

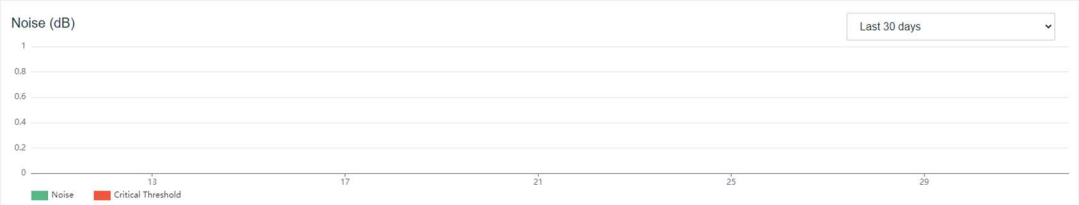
NOISE READINGS FROM NOISAU-008 – STAFF ACCOMMODATION OCTOBER

The noise readings from sensor NOISAU-008N, ceased due to Technical Difficulties ADCO is working to identify cause and rectify.

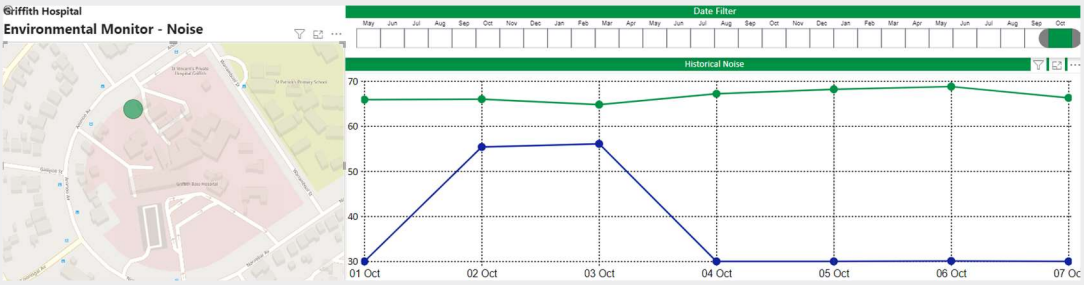
NOISE READINGS FROM NOISAU-009 – SITE SHEDS OCTOBER

The noise readings from sensor NOISAU-008N, ceased on 7th October due to Technical Difficulties at site, ADCO is working to identify cause and rectify. The noise readings from sensor NOISAU-009, located near the ADCO Site Sheds showed a peak noise value of 68.8dB on 6th October 2024.

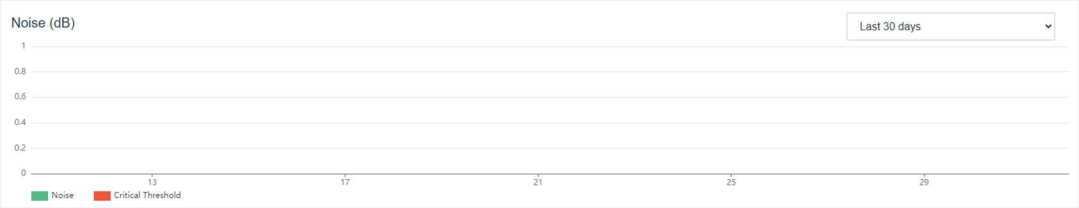
NOISE READINGS FROM NOISAU-005 – MEDICAL IMAGING NOVEMBER

Noise recordings ceased on 3rd November due Site Sheds decommissioning and ADCO plan to bring back online when re-established closer to Stage 2

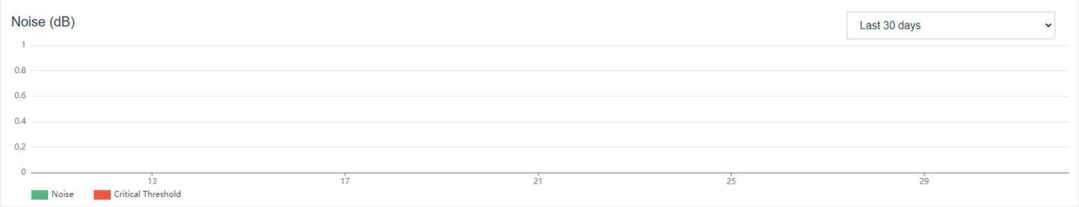
NOISE READINGS FROM NOISAU-008 – STAFF ACCOMMODATION NOVEMBER

Noise recordings ceased on 3rd November due Site Sheds decommissioning and ADCO plan to bring back online when re-established closer to Stage 2

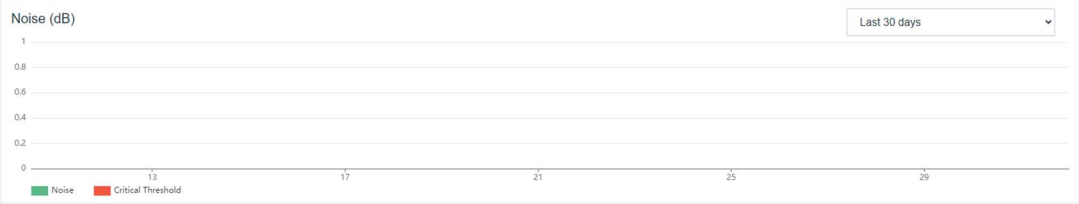
NOISE READINGS FROM NOISAU-009 – SITE SHEDS NOVEMBER

Noise recordings ceased on 3rd November due Site Sheds decommissioning and ADCO plan to bring back online when re-established closer to Stage 2
